HK QGS LIMITED Final Random Inspection Report

Client Ref. No.: 2250 | Report No.: 2250001 | Date: July 13th ,2022 | Total page: 13

GENERAL SUMMAI	GENERAL SUMMARY:					
Client:	Hayri GENC					
Product Description:	Second-hand excavator					
Supplier:	Shanghai Shenhu Packaging					
Supplier.	Machinery Equipment Co., Ltd.					
Contact person:	Leon					
Insp. Location:	Shanghai					
Inspector:	Parker					
Date of insp.:	July 13 th , 2022

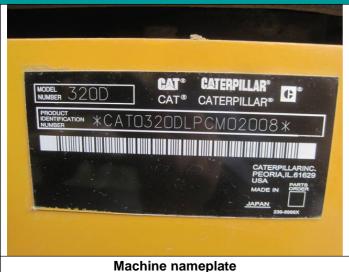
WORKMANS	HIP:			
Item .	Defects Description	Cri	Maj	Min
Second-hand excavator	Right side lamp at front middle arm was missing .	-	-	-
	Defects found:	-	1	-
	Max allow:	-	-	-
	Result:	Pendi	ng for re	emark

Machine view(Right side lamp missing)
